Adventures in VCDS.

Here are some things I have found that helped VCDS do what others seemed to make happen with ease. I have been using both the Release version and the Beta version.

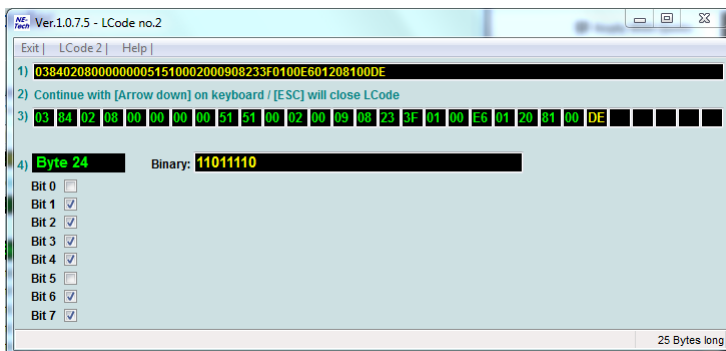
In the top left of the window, click LCode2 and another coding window will appear.

The second coding window will let you tick or untick the bits.

After doing this for the first time, VCDS seems to remember and each time after will show the editable window.

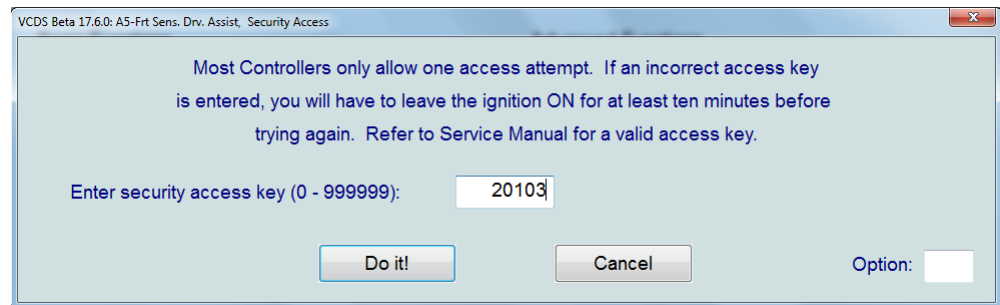
When making changes here for items such as Traffic Sign Recognition and High Beam Assist, a password is required. VCDS does not pre-fill this password as it does for other controllers.

The Security Access number for this controller is 20103.

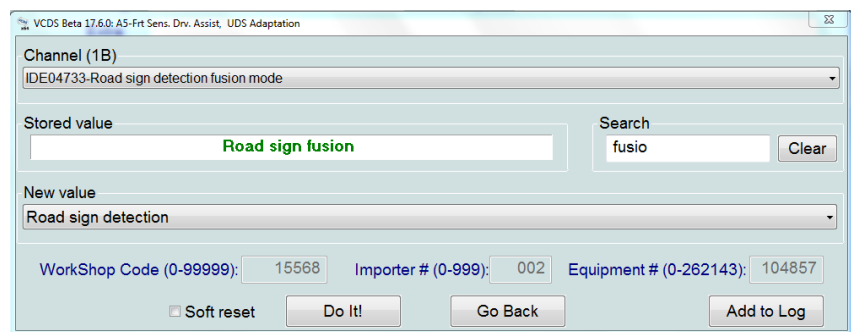
To get the TSR to work, I switched the value "Road sign fusion" to "Road sign detection".

Hint: typing the first few letters of the item you are looking for in the search box will narrow down the options in the channel pull down menu.
